GREEN LANE RESERVOIR DAM

NDI - PA 00618
PA DER 46-250

PHASE I INSPECTION REPORT
NATIONAL DAM INSPECTION PROGRAM

OVERVIEW
GREEN LANE RESERVOIR DAM, MONTGOMERY COUNTY, PENNSYLVANIA

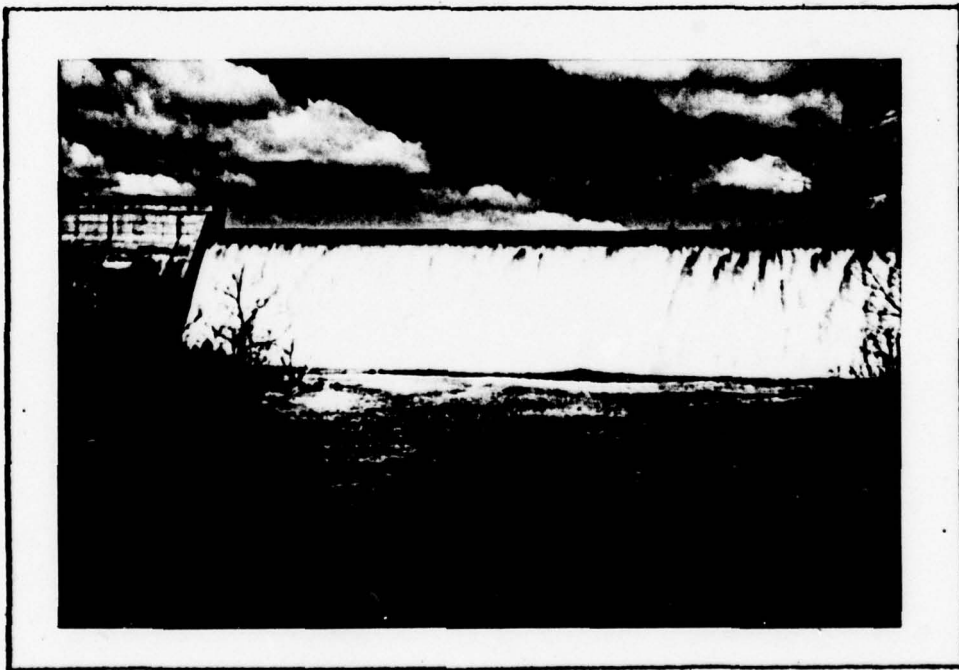
*LOOKING UPSTREAM AT THE
OVERFLOW SPILLWAY*

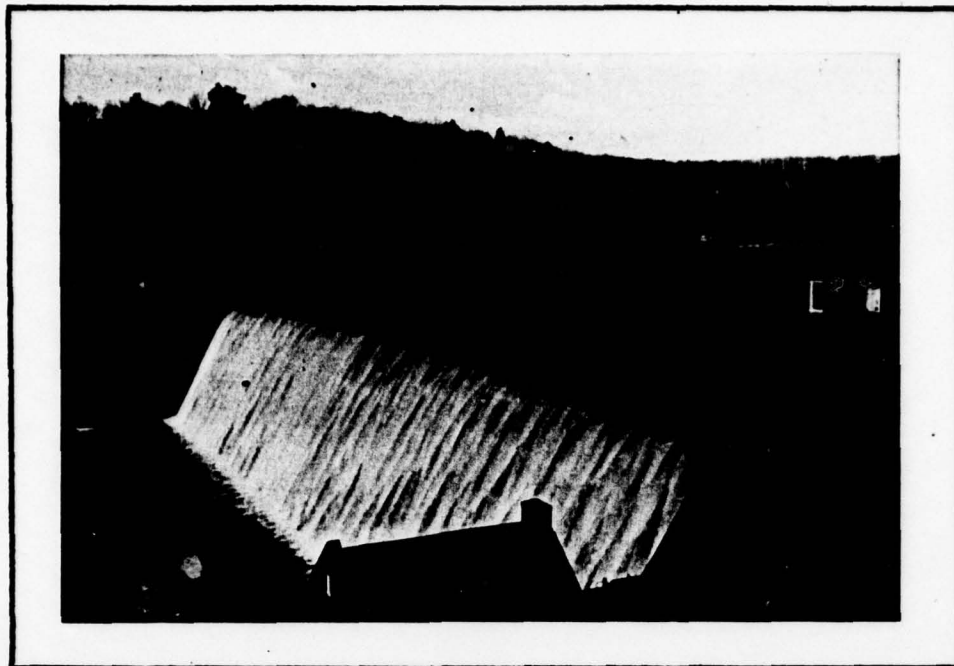
*OVERFLOW SPILLWAY FROM THE LEFT
ABUTMENT LOOKING SOUTH*

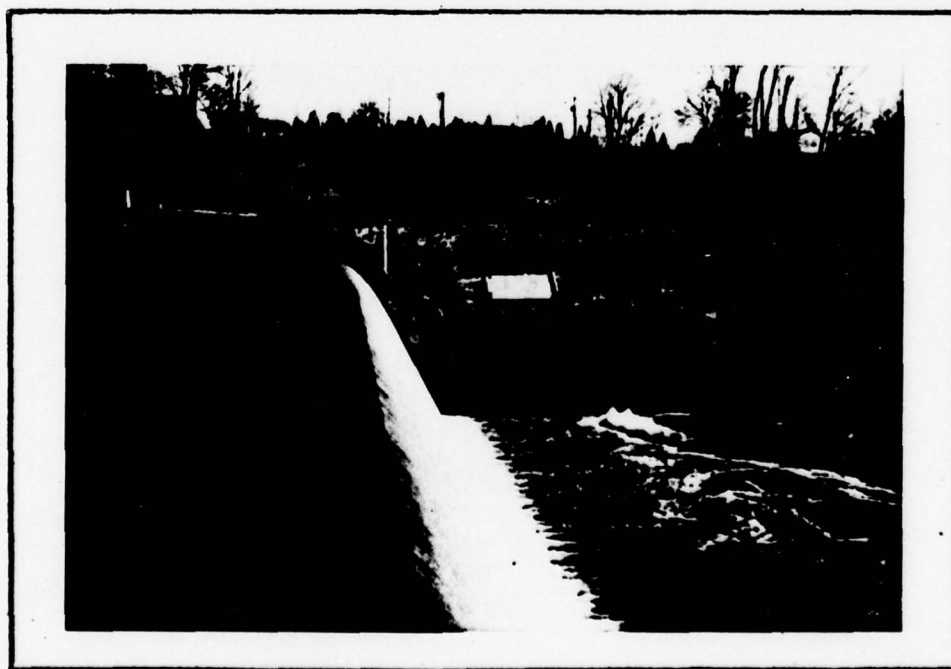
*OVERFLOW SPILLWAY AND GATEHOUSE
FROM THE RIGHT ABUTMENT LOOKING NORTH*

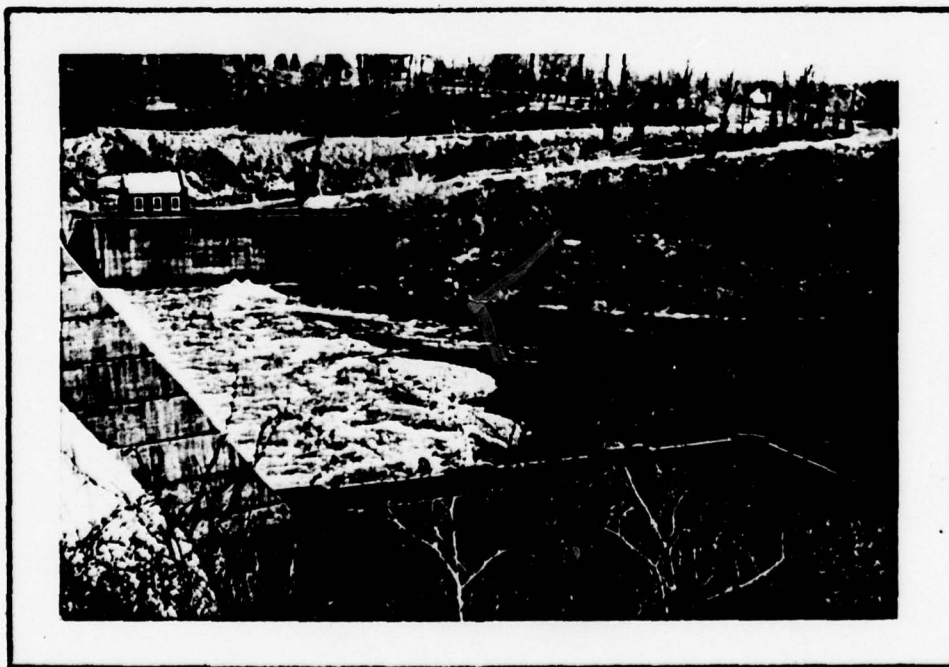
f. Downstream Channel. Sand and gravel deposits, located approximately 200 feet downstream from the spillway toe, were noted within the spillway channel. A thorough investigation to determine the source of these deposits was prevented due to flow conditions at the time of inspection. The deposits could be the result of channel erosion or remnants of former islands in the channel.

*OVERFLOW SPILLWAY OUTLET CHANNEL
SHOWING SAND AND GRAVEL DEPOSITS*

1. A thorough investigation of the channel bottom immediately downstream from the spillway should be performed to determine the source of the sand and gravel deposits observed during the visual inspection.
